**Re: Site Profile Submission – Site Decommissioning
377 to 407 Gower Point Road and 689 Winn Road, Gibsons
PIDs: 007-359-870, 007-359-829, 011-118-202, 011-118-211 and 011-117-524**

Re: Improper Contamination Assessment, Hyak Marine property, Gibsons, BC

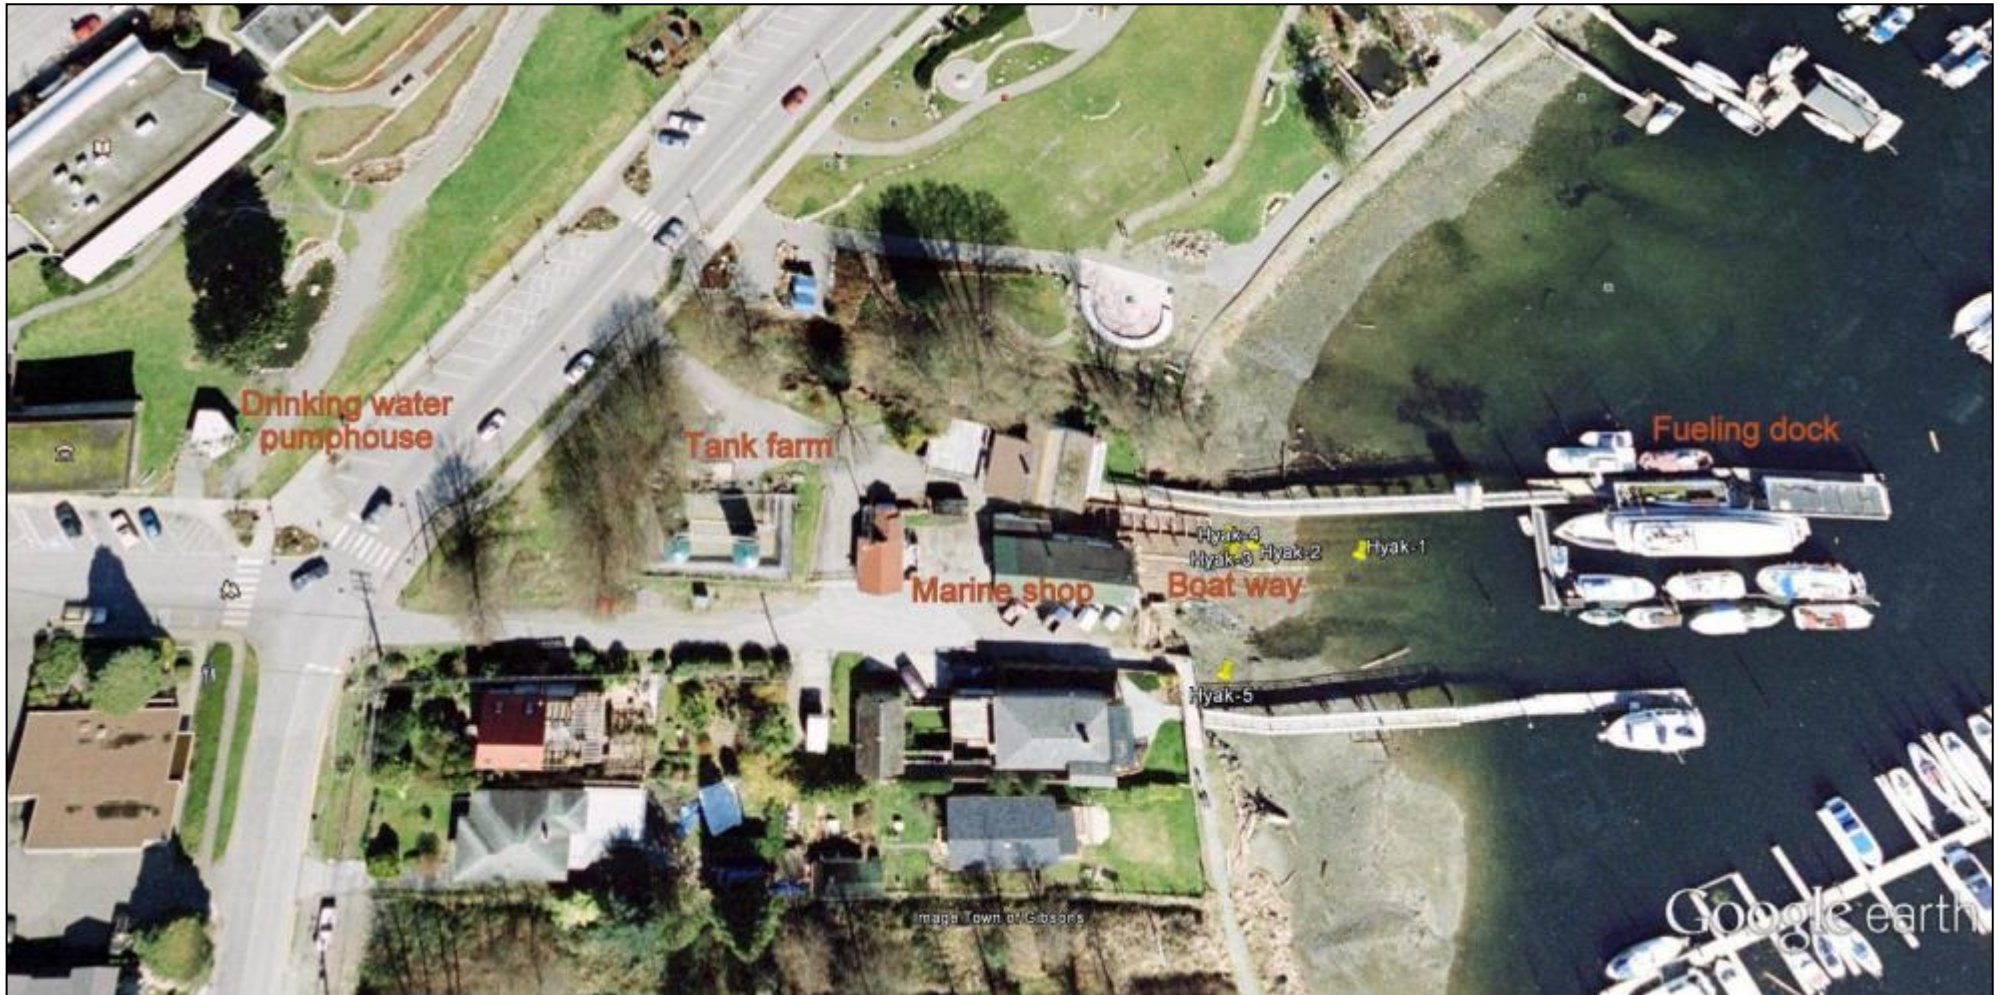
These areas are shown in the satellite photograph in Figure 1 (below) and will be discussed separately.

By far, the most potent toxicant at the site is tributyltin (TBT), an anti-fouling agent that was banned nearly 20 years ago. Inexplicably, Balanced omitted to analyze foreshore sediments for TBT, though they cite an earlier report indicating that TBT was detected in these sediments. I collected five sediment samples (using methods that preserve sample integrity) that are geo-referenced in Figure 1, and **found high TBT levels in two out of five samples** (reporting at 1.49 and 2.73 µg/dry g). Given the high toxicity of TBT, this omission by Balanced begs disbelief.

Balanced has characterized some of the contamination in soils and sediments on the Hyak property, but it is evident they neglected to look for the most toxic contaminant – TBT – or sample sediments to be dredged in the harbour. **The test results from my own investigations indicate that TBT is present on this site at concentrations that pose a high risk (>2.5 µg/dry g).**

Figure 1. General layout of Hyak property and sediment sample location (labelled yellow pins) for TBT analysis.
